Geotechnical Investigation for Proposed Residential Subdivision at 158 Vinegar Hill Road, Kauri – Resource Consent 2

Job No. NL20029/S2

**GEOTECHNICAL INVESTIGATION
FOR PROPOSED RESIDENTIAL SUBDIVISION AT
158 VINEGAR HILL ROAD, KAURI
RESOURCE CONSENT 2**

Job Number:	NL20029/S2
Name of Project:	158 Vinegar Hill Road, Kauri – Resource Consent 2
Client:	Evo Land Ltd
Author:	Randy Lineses, Senior Geotechnical Engineer, MEngNZ
Reviewer:	Csaba Hegedus, Geotechnical Engineer, MEngNZ
Authoriser:	Bruce Green, Principal Geotechnical Engineer, CMEngNZ, CPEng
Document Version:	A
Printed:	24 May 2021
Author Signature:	
Reviewer Signature:	
Authoriser Signature:

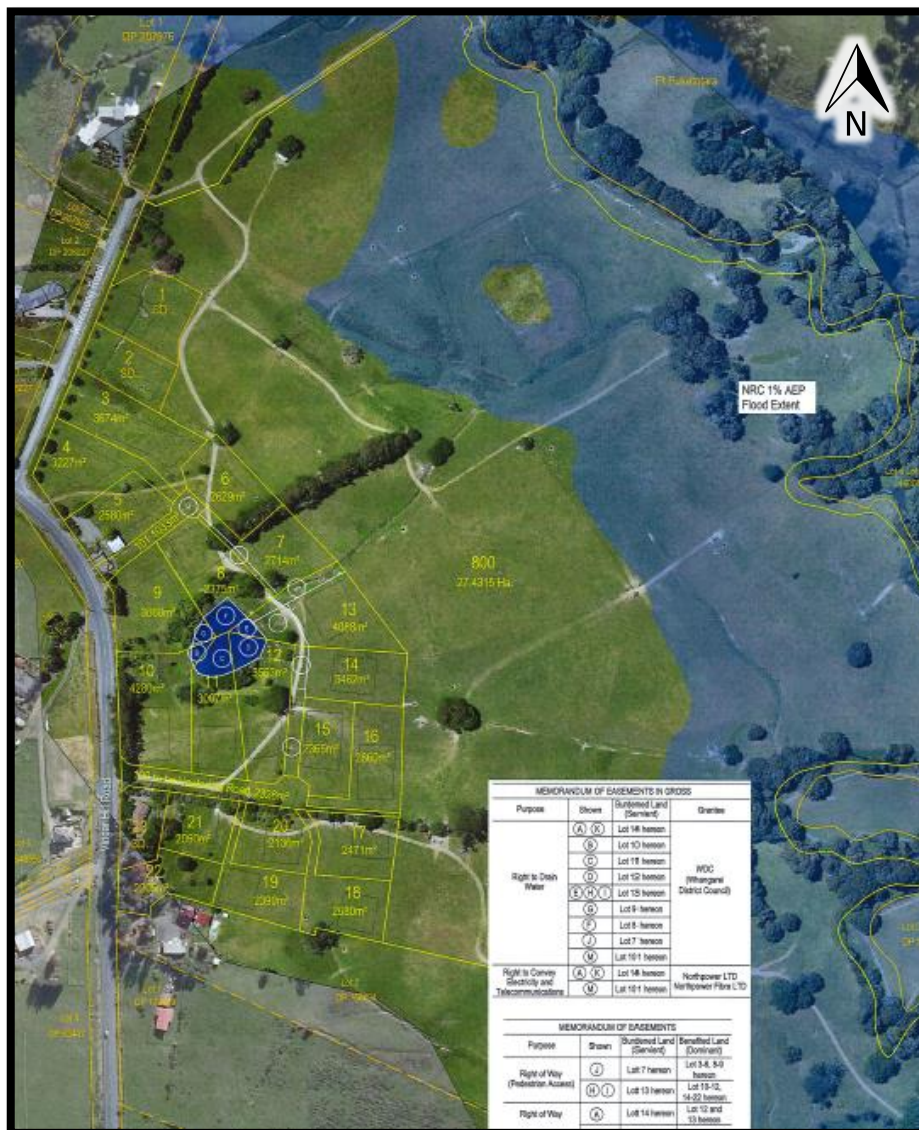
Figure 2: Proposed Subdivision (Source: Cato Bolam Consultants)

Drawings prepared by Cato Bolam show the proposal is to subdivide the overall property into a total of sixty-one rural-residential Lots. Under the 'Resource Consent 2' (RC2) application the site will be subdivided for residential development for Lot 3 to Lot 22 inclusive and the Balance Lot 800. The proposed RC2 residential development is generally situated to the west of the property as shown in Figure 2 below and will be referred to collectively as 'the site' in this report. No development is proposed on the balance Lot 800. Access to the individual lots will be via common driveways from Vinegar Hill Road.

The same set of plans shows a 1% Annual Exceedance Probability (AEP) flood plain is present to the east of the site. These areas will be included in a 'Resource Consent 3' report at a later date.

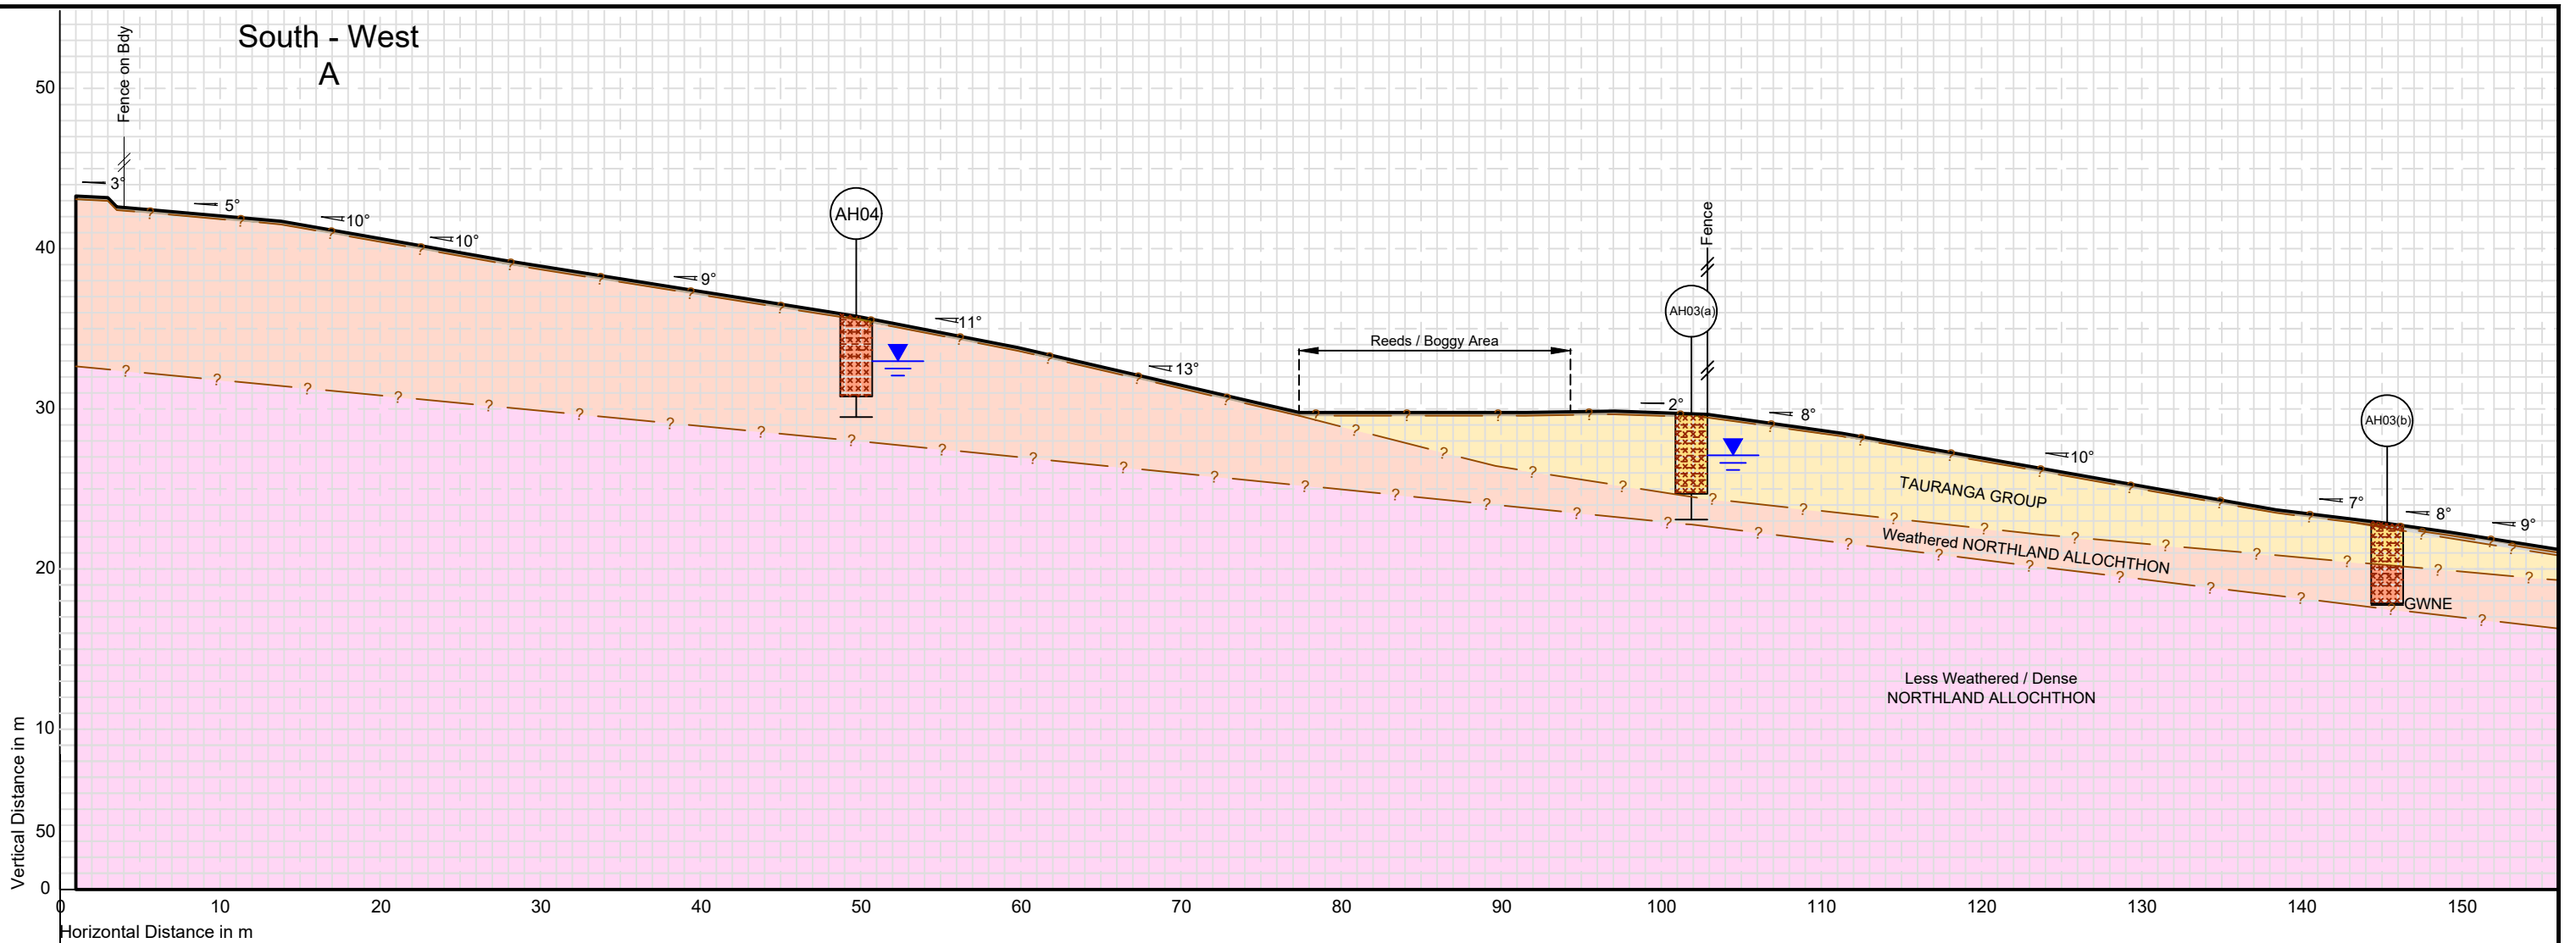
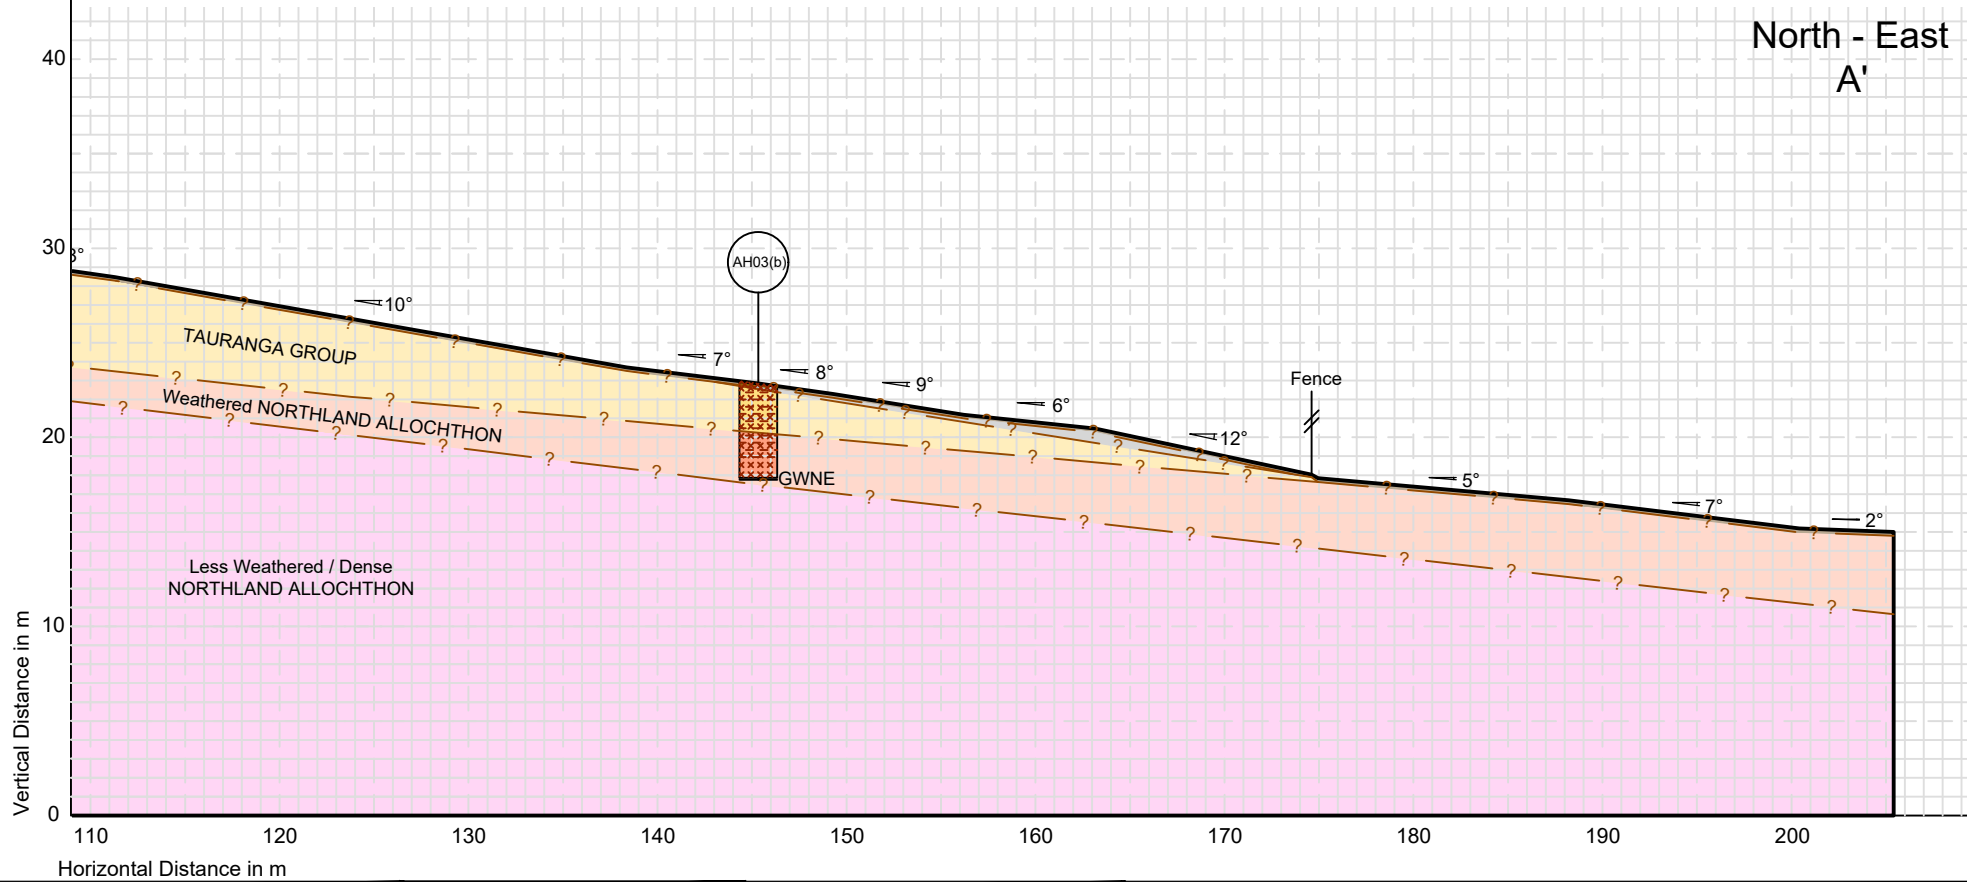
CROSS SECTION A-A'

South - West
A

North - East
A'

Section	Modelled Conditions	Global Factor of Safety		Compliant
		Required	Calculated	
A-A'	Normal Groundwater	1.5	2.2	Yes
	Extreme (Worst Credible) Groundwater	1.3	1.9	Yes
	Seismic Loading	1.2	1.2	Yes
C-C'	Normal Groundwater	1.5	2.5	Yes
	Extreme (Worst Credible) Groundwater	1.3	2.0	Yes
	Seismic Loading	1.2	1.5	Yes
D-D'	Normal Groundwater	1.5	2.2	Yes
	Extreme (Worst Credible) Groundwater	1.3	1.7	Yes
	Seismic Loading	1.2	1.3	Yes

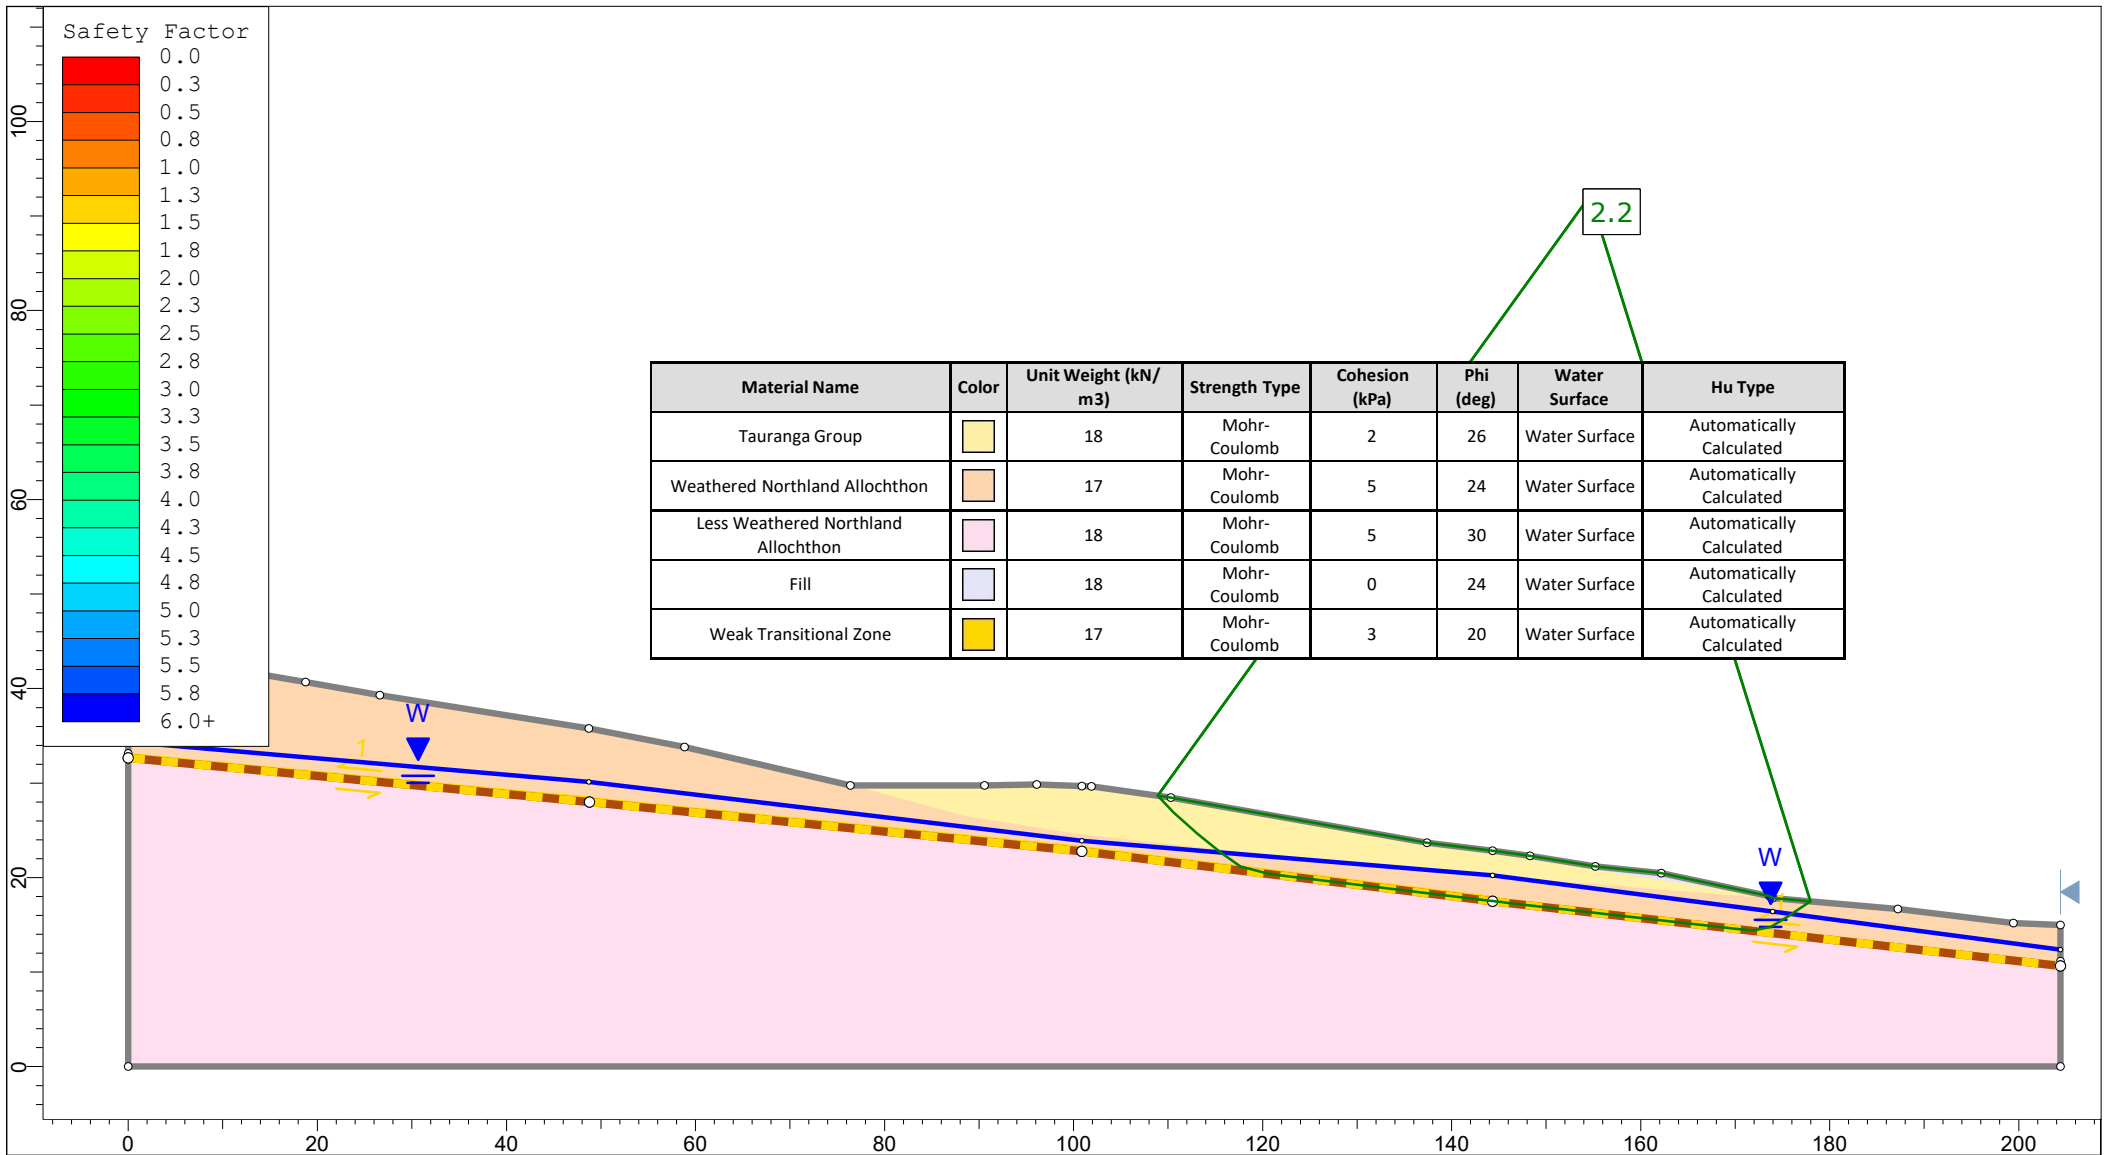
Soil & Rock Consultants <i>Your responsive & cost-effective engineers</i>	Project		158 Vinegar Hill Road, Kauri		
	Group		Section A-A'	Scenario	Normal Groundwater Condition - Non Circular
	Drawn By		RL	Company	Soil & Rock Consultants
	Date		25 January 2021	File Name	A-A'.slmd
	SLIDEINTERPRET 9.008

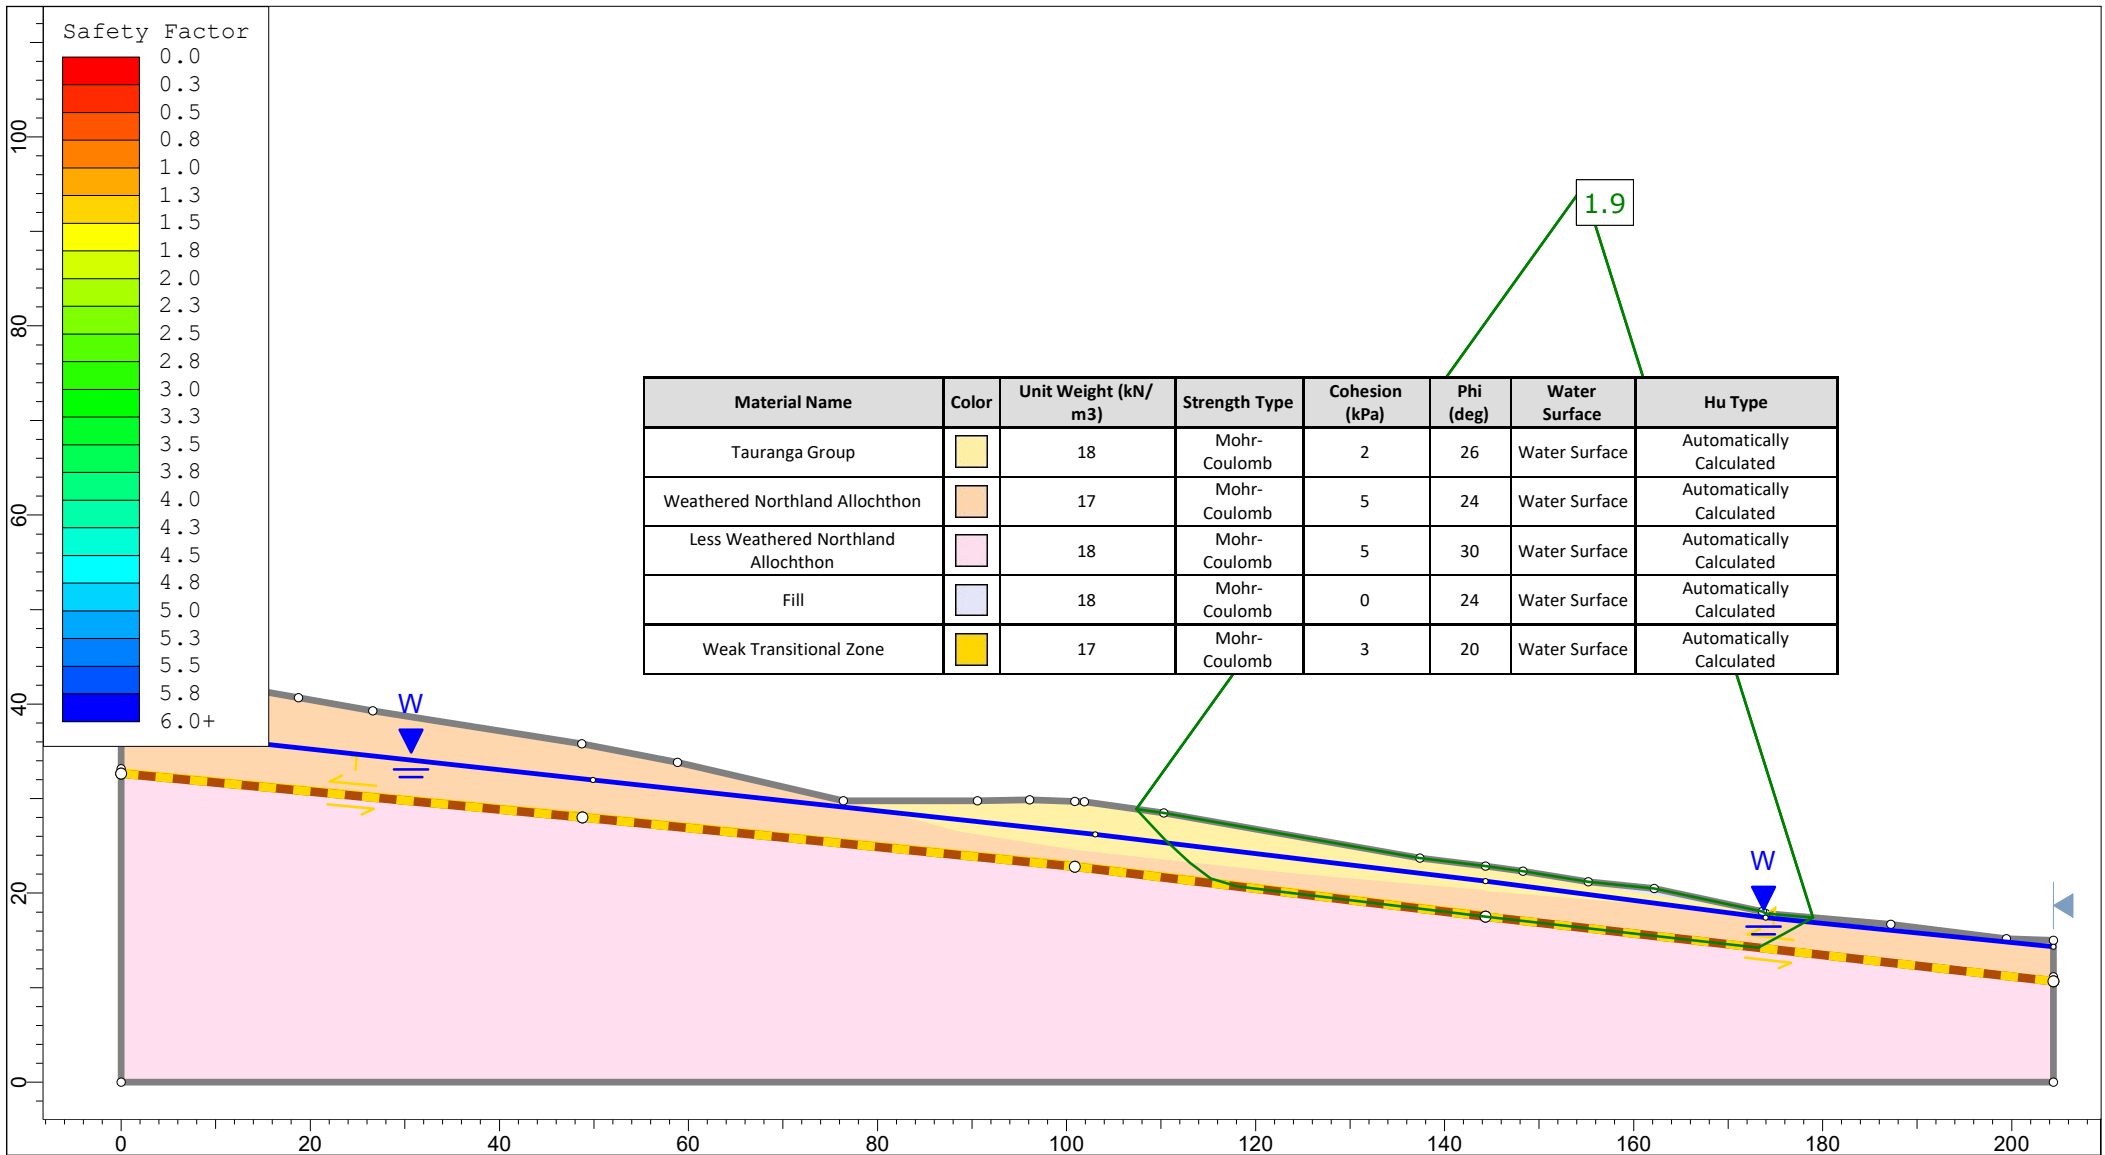
Soil & Rock Consultants <i>Your responsive & cost-effective engineers</i>	Project	158 Vinegar Hill Road, Kauri		
	Group	Section A-A'	Scenario	Extreme Groundwater Condition - Non Circular
	Drawn By	RL	Company	Soil & Rock Consultants
	Date	25 January 2021	File Name	A-A'.slmd
	SLIDEINTERPRET 9.008

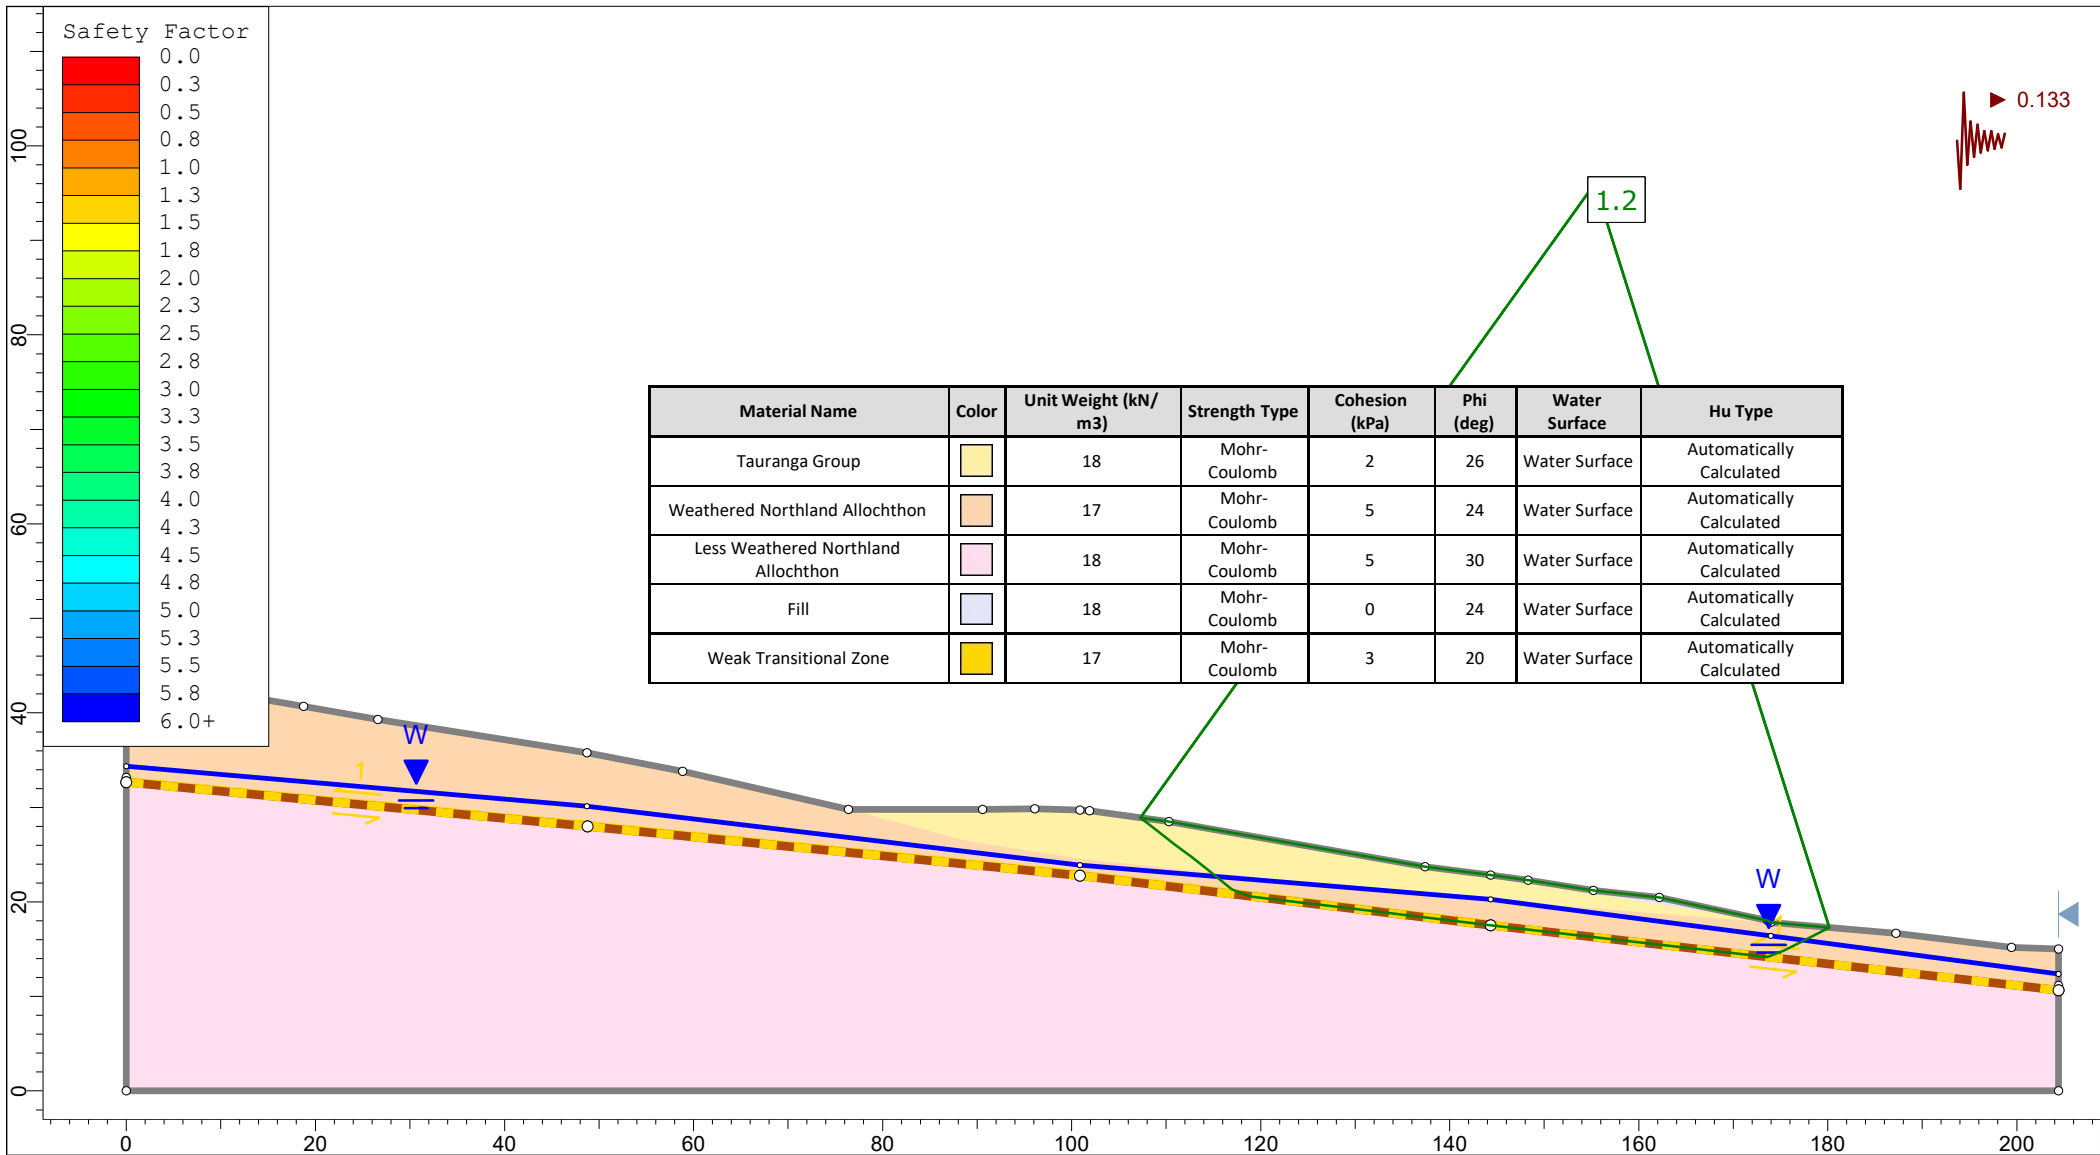
<p>Soil & Rock Consultants Your responsive & cost-effective engineers</p>	Project	158 Vinegar Hill Road, Kauri		
	Group	Section A-A'	Scenario	Seismic Condition - Non Circular
	Drawn By	RL	Company	Soil & Rock Consultants
	Date	25 January 2021	File Name	A-A'.slmd

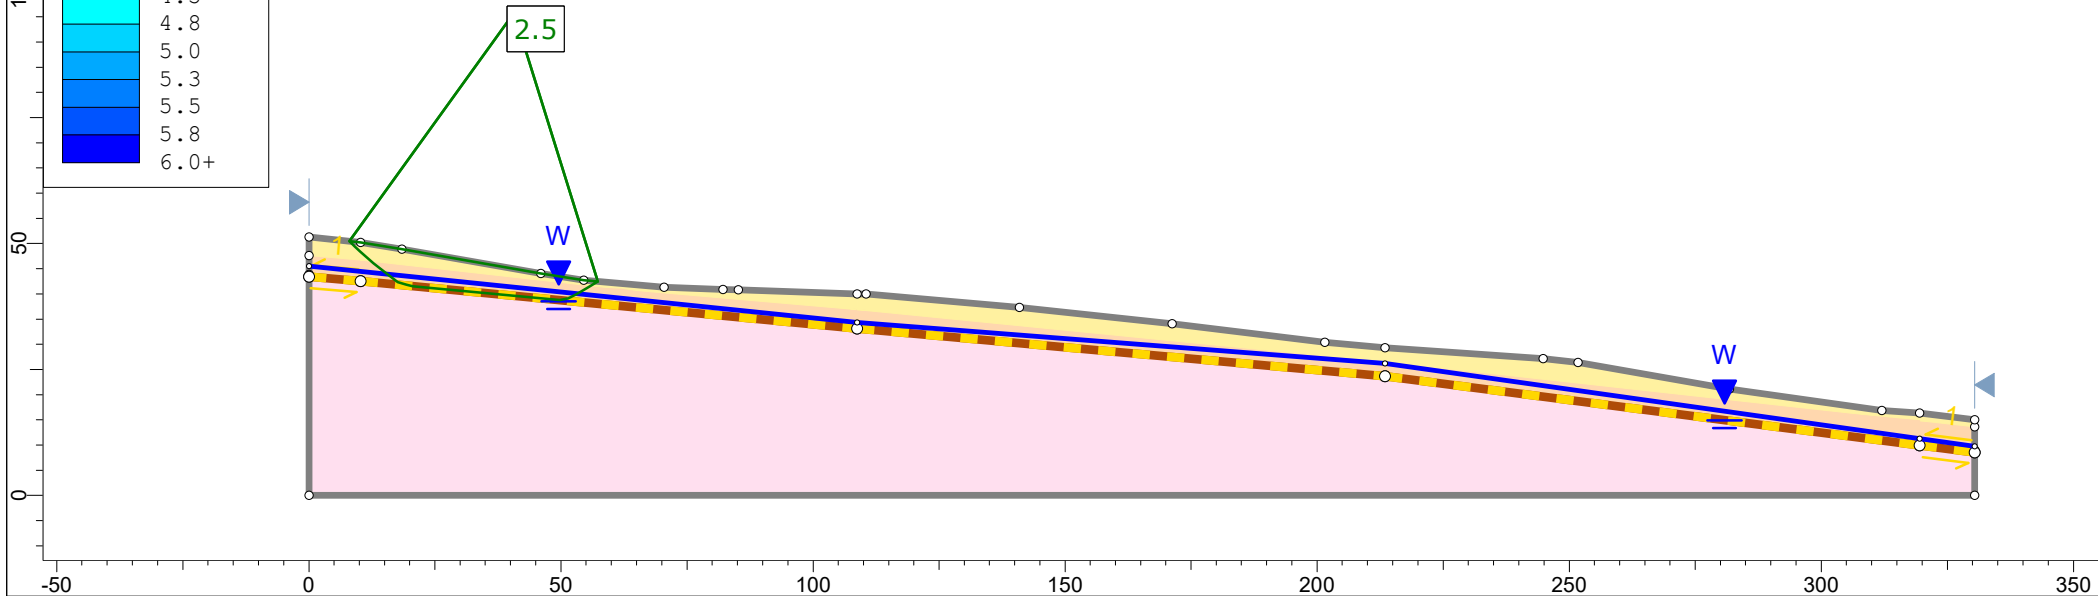
<p>Soil & Rock Consultants Your responsive & cost-effective engineers</p>	Project	158 Vinegar Hill Road, Kauri		
	Group	Section C-C'	Scenario	Normal Groundwater Condition - Non Circular
	Drawn By	RL	Company	Soil & Rock Consultants
	Date	14 January 2021	File Name	C-C'.slmd

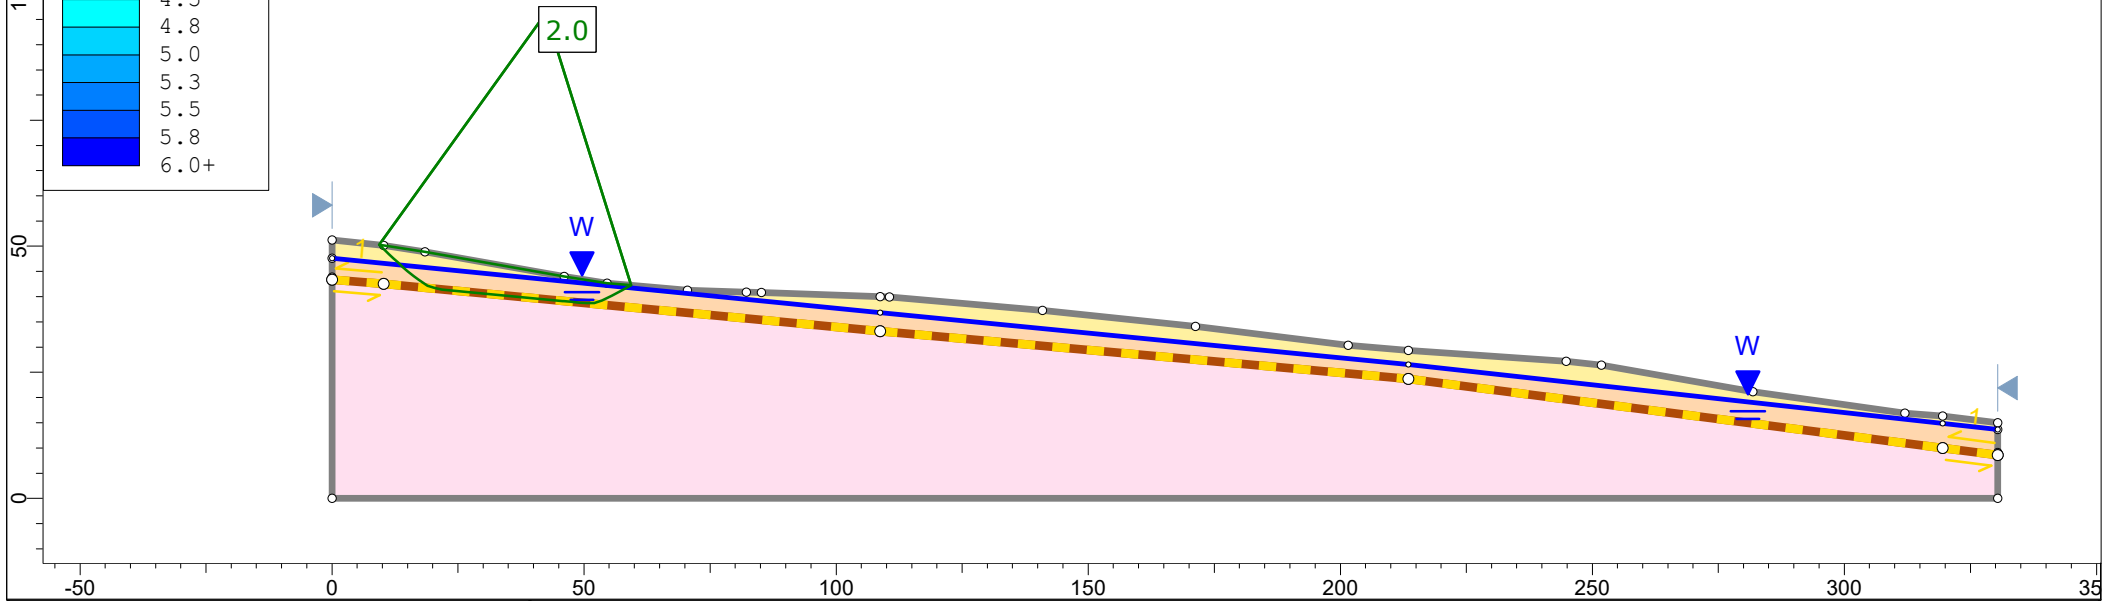
<p>Soil & Rock Consultants Your responsive & cost-effective engineers</p>	Project	158 Vinegar Hill Road, Kauri		
	Group	Section C-C'	Scenario	Extreme Groundwater Condition - Non Circular
	Drawn By	RL	Company	Soil & Rock Consultants
	Date	14 January 2021	File Name	C-C'.slmd

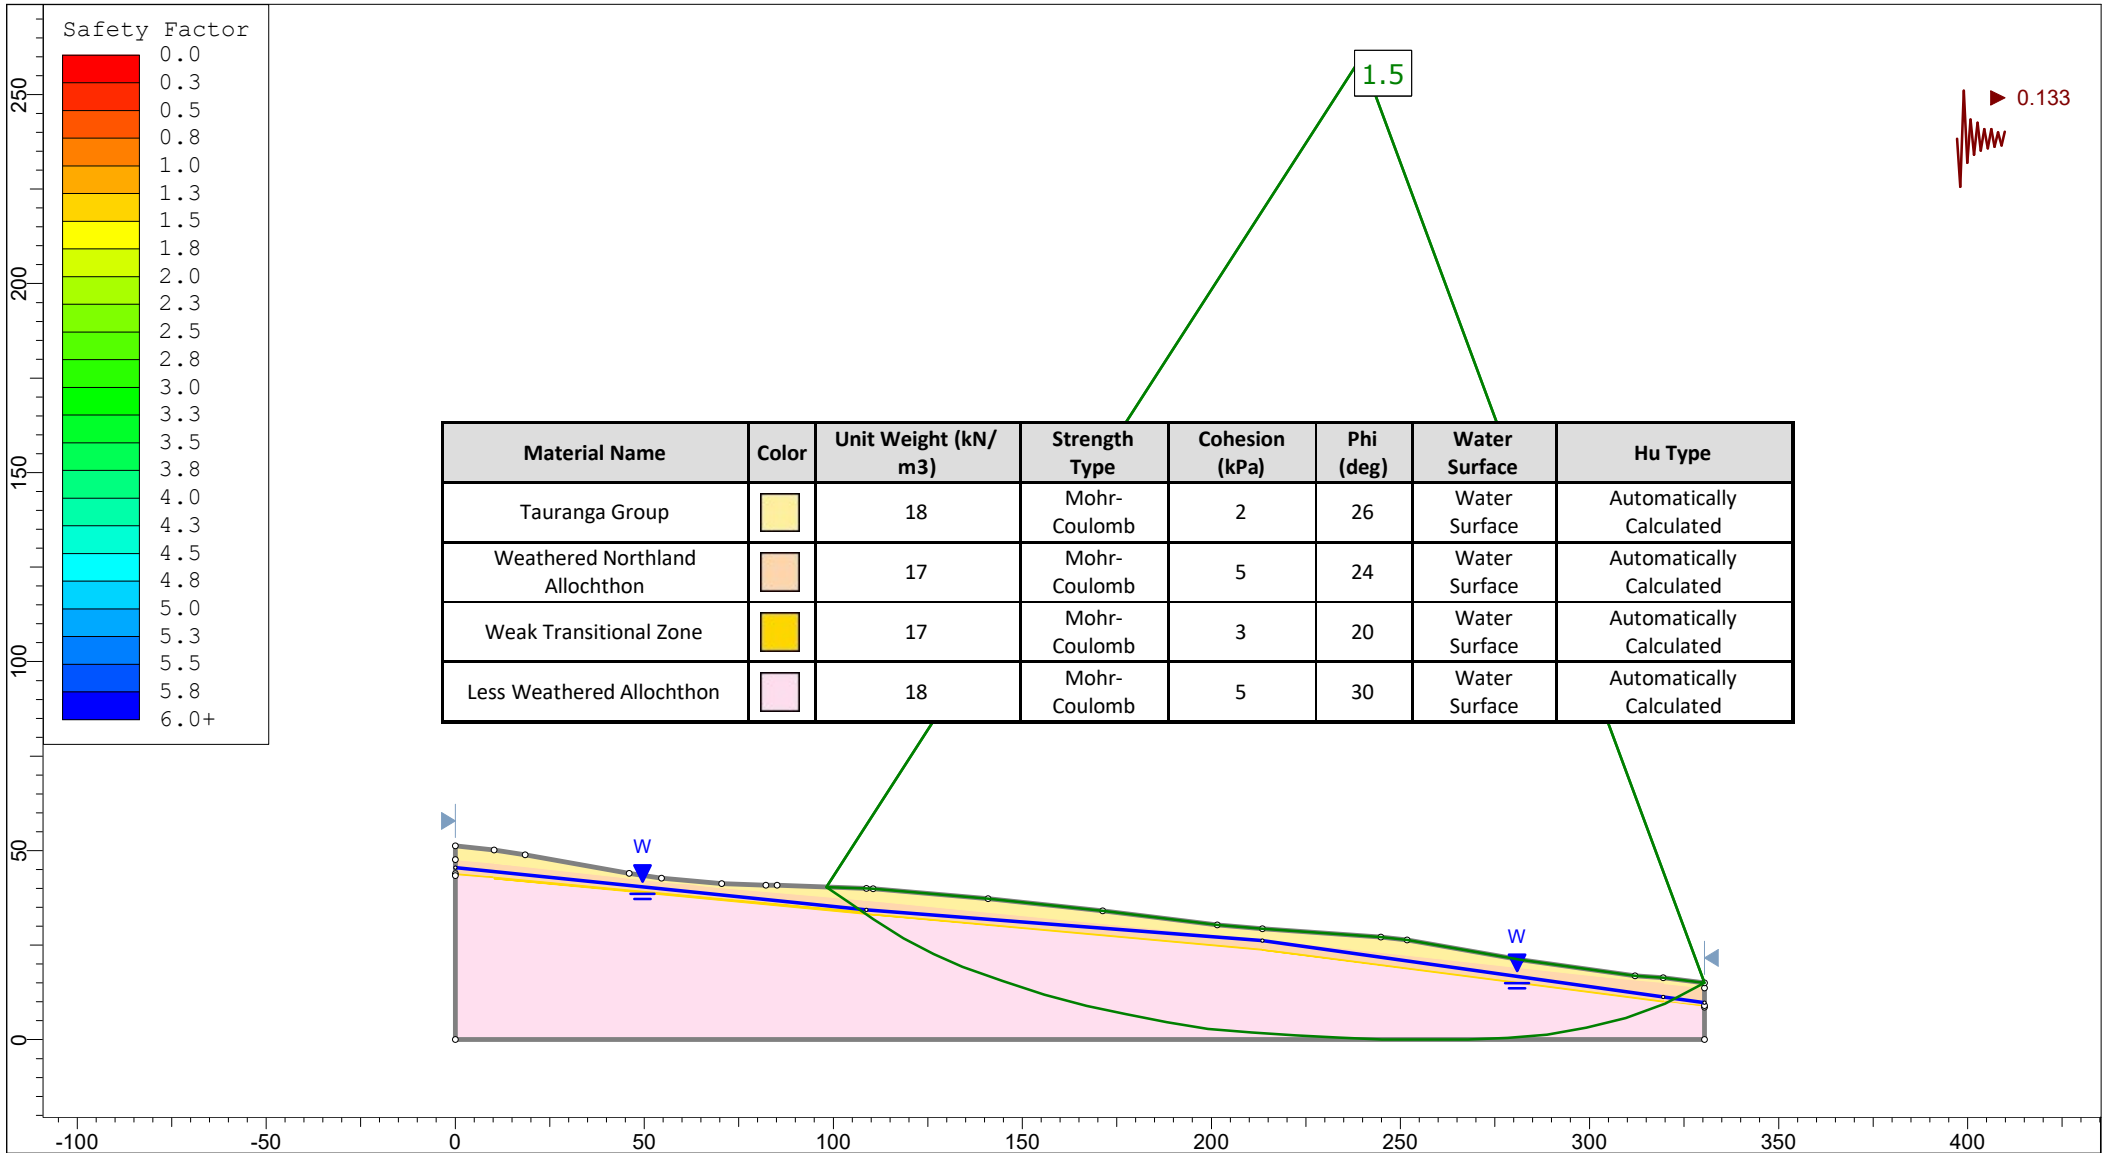
<p>Soil & Rock Consultants Your responsive & cost-effective engineers</p>	Project	158 Vinegar Hill Road, Kauri	
	Group	Section C-C'	Scenario Seismic Condition - Non Circular
	Drawn By	RL	Company Soil & Rock Consultants
	Date	14 January 2021	File Name C-C'.slmd

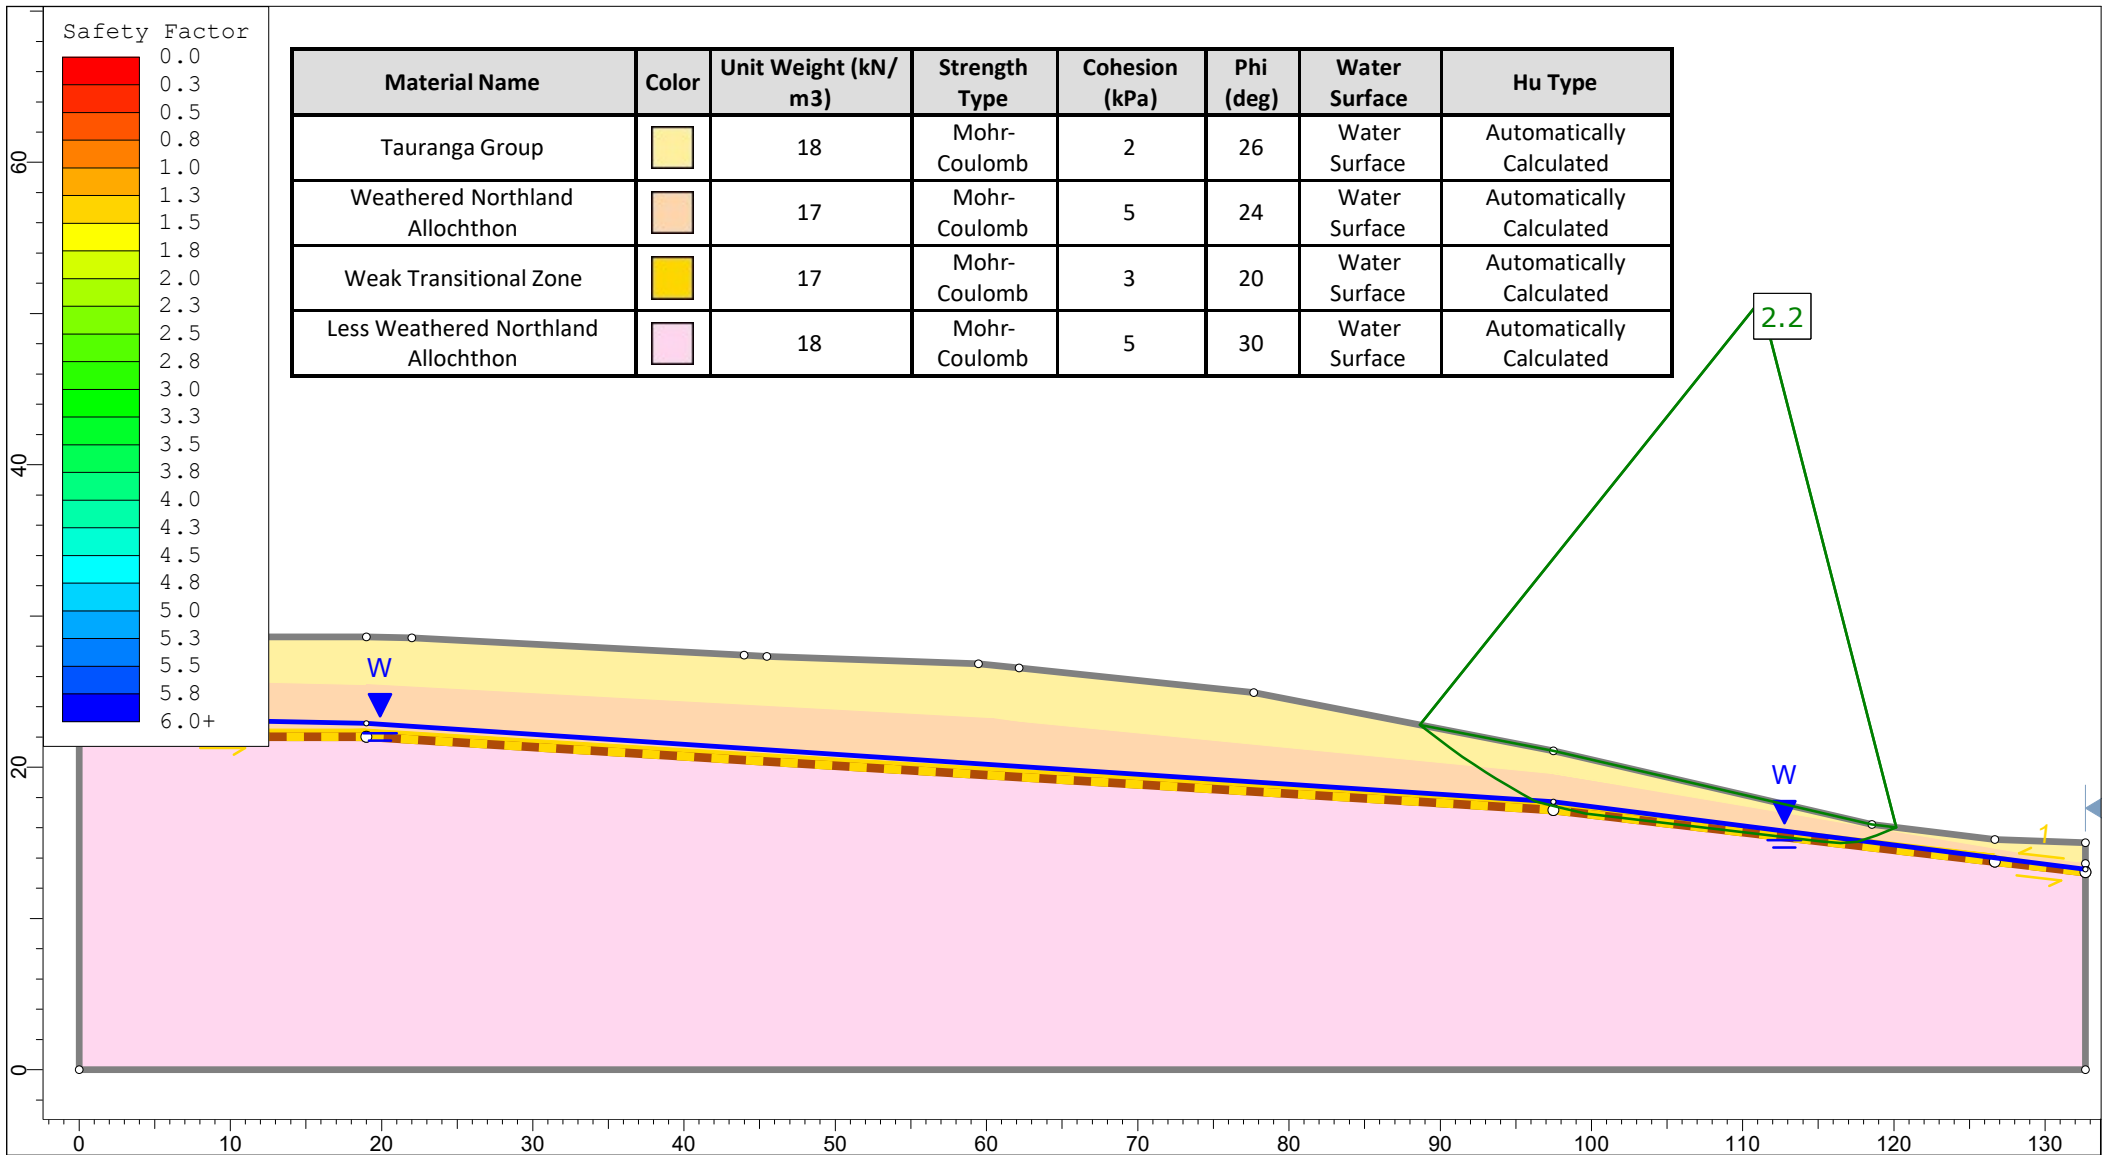
Soil & Rock Consultants <i>Your responsive & cost-effective engineers</i>	Project		158 Vinegar Hill Road, Kauri		
	Group		Section D-D'	Scenario	Normal Groundwater Condition - Non Circular
	Drawn By		RL	Company	Soil & Rock Consultants
	Date		25 January 2021	File Name	D-D'.slmd
