Geotechnical Investigation for Proposed Residential Subdivision at 158 Vinegar Hill Road, Kauri – Resource Consent 2

Job No. NL20029/S2

**GEOTECHNICAL INVESTIGATION
FOR PROPOSED RESIDENTIAL SUBDIVISION AT
158 VINEGAR HILL ROAD, KAURI
RESOURCE CONSENT 2**

Job Number:	NL20029/S2
Name of Project:	158 Vinegar Hill Road, Kauri – Resource Consent 2
Client:	Evo Land Ltd
Author:	Randy Lineses, Senior Geotechnical Engineer, MEngNZ
Reviewer:	Csaba Hegedus, Geotechnical Engineer, MEngNZ
Authoriser:	Bruce Green, Principal Geotechnical Engineer, CMEngNZ, CPEng
Document Version:	A
Printed:	24 May 2021
Author Signature:	
Reviewer Signature:	
Authoriser Signature:

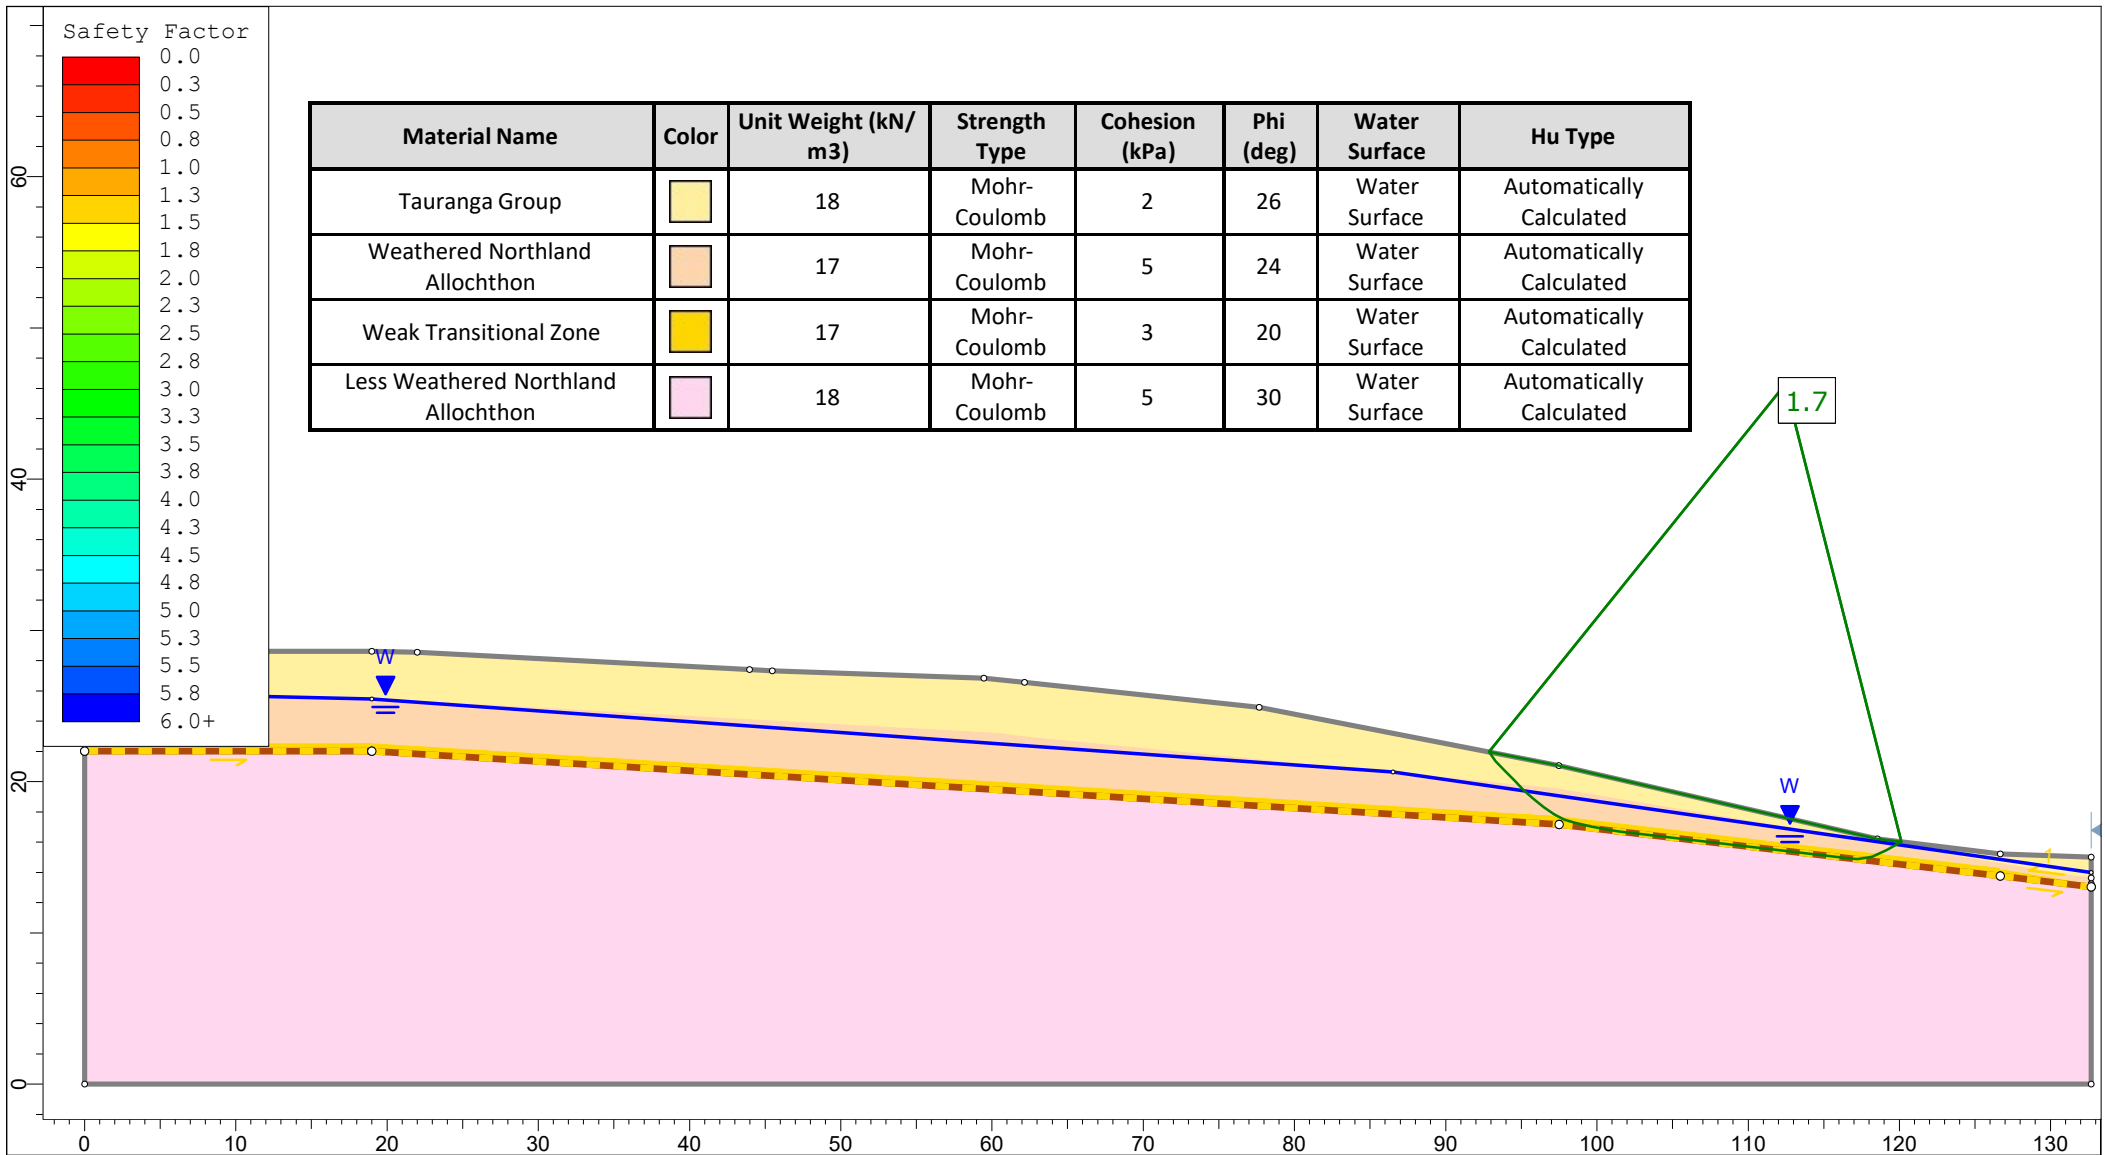
Soil & Rock Consultants <i>Your responsive & cost-effective engineers</i>	Project		158 Vinegar Hill Road, Kauri		
	Group		Section D-D'	Scenario	Extreme Groundwater Condition - Non Circular
	Drawn By		RL	Company	Soil & Rock Consultants
	Date		25 January 2021	File Name	D-D'.slmd

Section	Modelled Conditions	Global Factor of Safety		Compliant
		Required	Calculated	
A-A'	Normal Groundwater	1.5	2.2	Yes
	Extreme (Worst Credible) Groundwater	1.3	1.9	Yes
	Seismic Loading	1.2	1.2	Yes
C-C'	Normal Groundwater	1.5	2.5	Yes
	Extreme (Worst Credible) Groundwater	1.3	2.0	Yes
	Seismic Loading	1.2	1.5	Yes
D-D'	Normal Groundwater	1.5	2.2	Yes
	Extreme (Worst Credible) Groundwater	1.3	1.7	Yes
	Seismic Loading	1.2	1.3	Yes

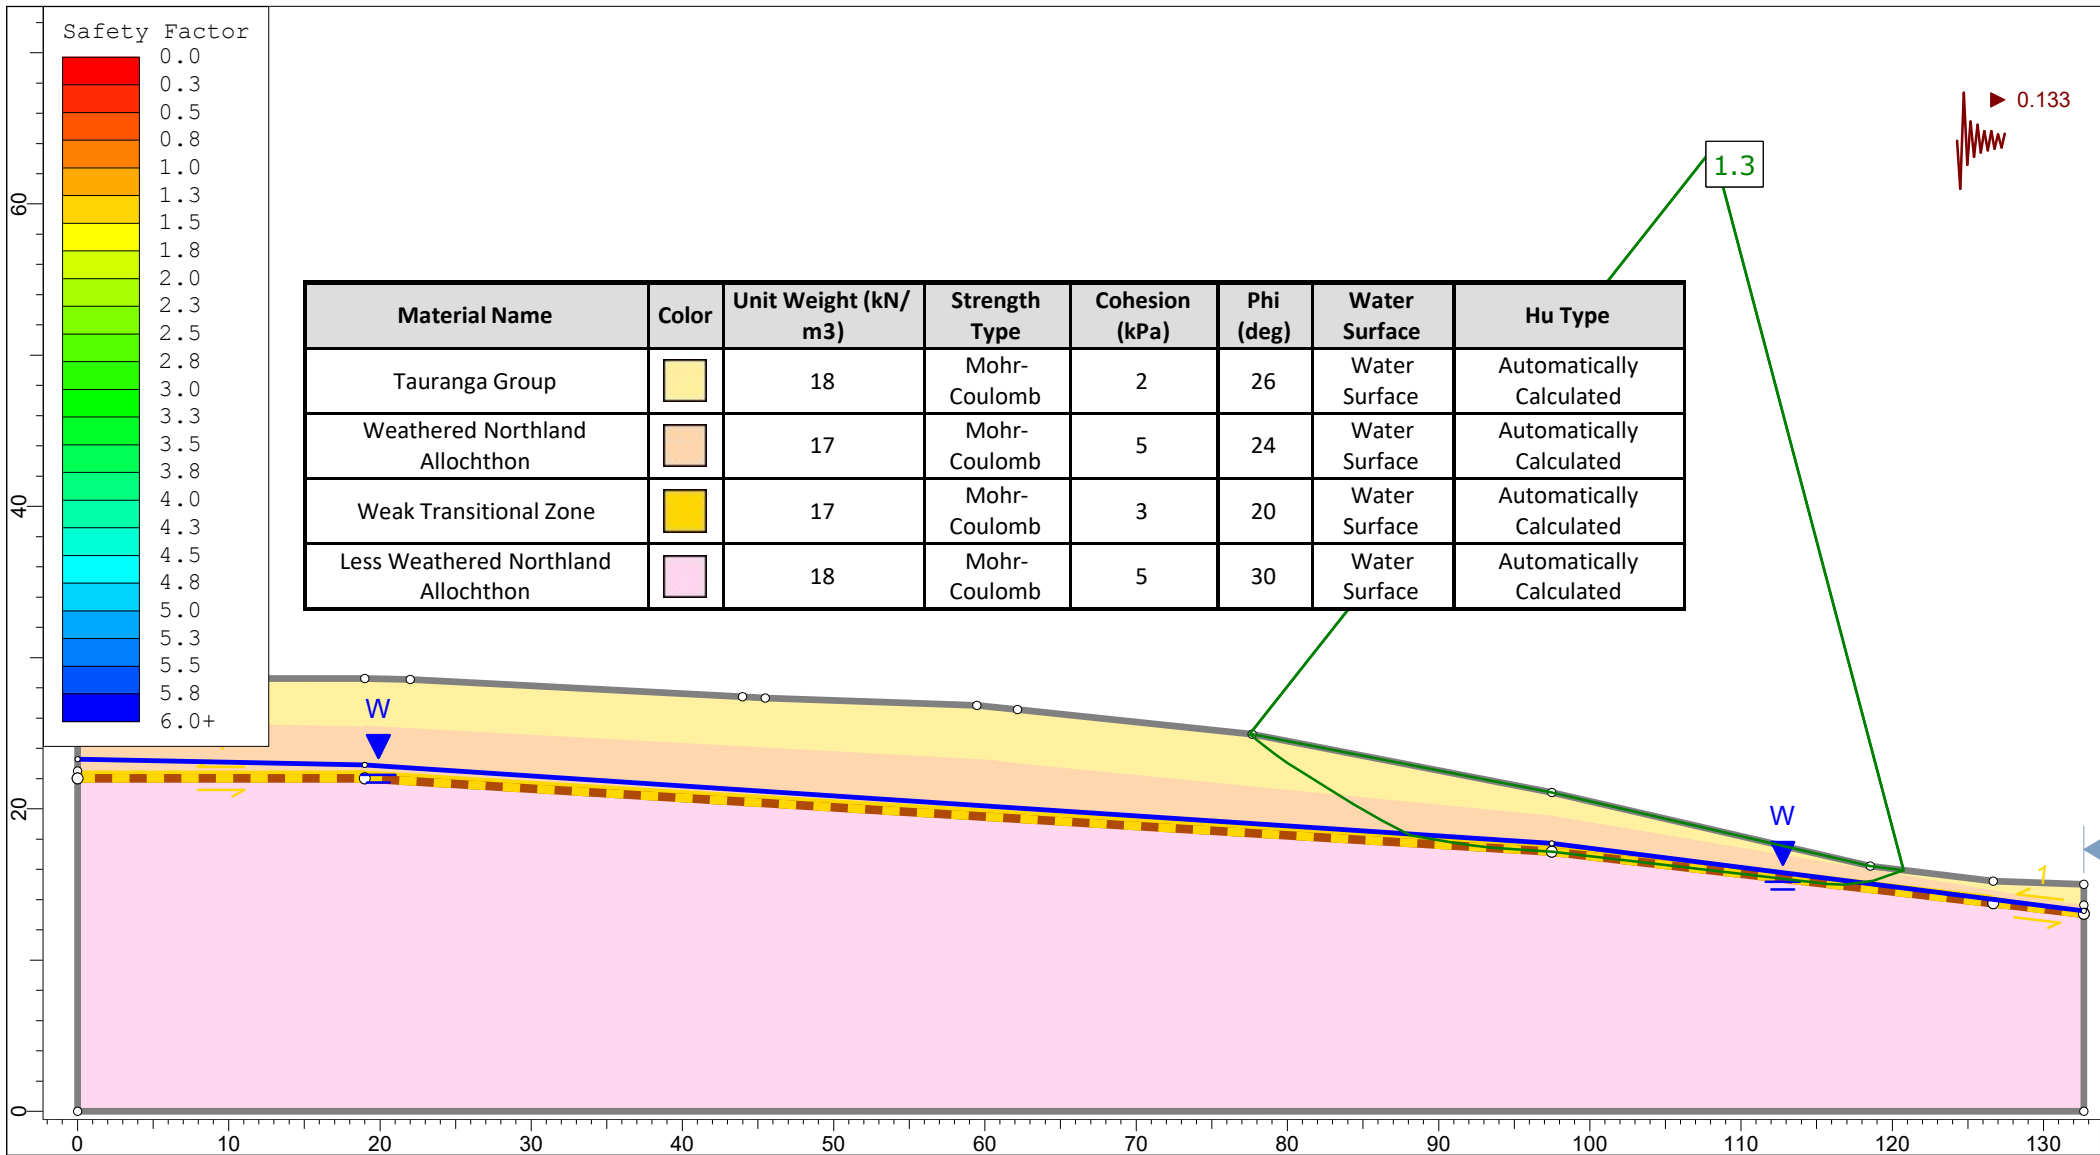
Soil & Rock Consultants <i>Your responsive & cost-effective engineers</i>	Project	158 Vinegar Hill Road, Kauri		
	Group	Section D-D'	Scenario	Seismic Condition - Non Circular
	Drawn By	RL	Company	Soil & Rock Consultants
	Date	25 January 2021	File Name	D-D'.slmd
